MEETING NOTES

TOPIC: Relocation of Colaboracion I, II and III Head Start Center in the Cabo Rojo Township

**MEJORAS A PLANTA FISICA PARA RE LOCALIZACIÓN DEL
CENTRO HEAD START
COLABORACION I, II Y III**
UBICACIÓN: PREDIOS DEL CENTRO REBECCA COLBERG

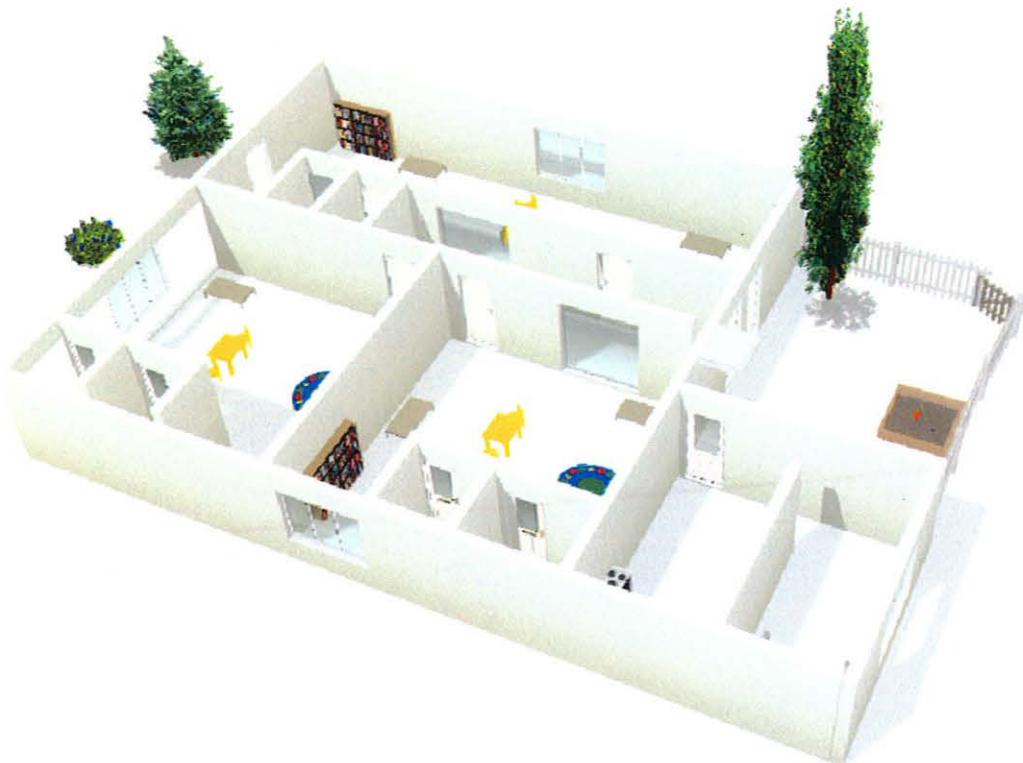
- d. The fourth option is a location in the Rebecca Colberg Stadium, built for the Central American Games. The address is 312 Road, Hm. 0.4, Cabo Rojo, Puerto Rico.

- i. This 2,205 sq. ft. location is currently in disuse.
 - ii. It has two (2) 750 sq. ft rooms with installed showers and another room of 795 sq. ft.
 - iii. All showers are removable and the spaces are adequate for three classrooms.

- iv. Renovation contract would need to include the expansion of the facility for kitchen and food storage areas between the Stadium facilities and a Municipal Museum.

- v. An area of 1,500 sq ft will be available in front of the kitchen and the storage, an ideal space for the children playground. This area should be marked out with a 6-ft.-tall fence of PVC, iron or wood.

- vi. The terms of contract should include water leaking repairs, replacement of galvanum roof and connection to the Stadium power substation.

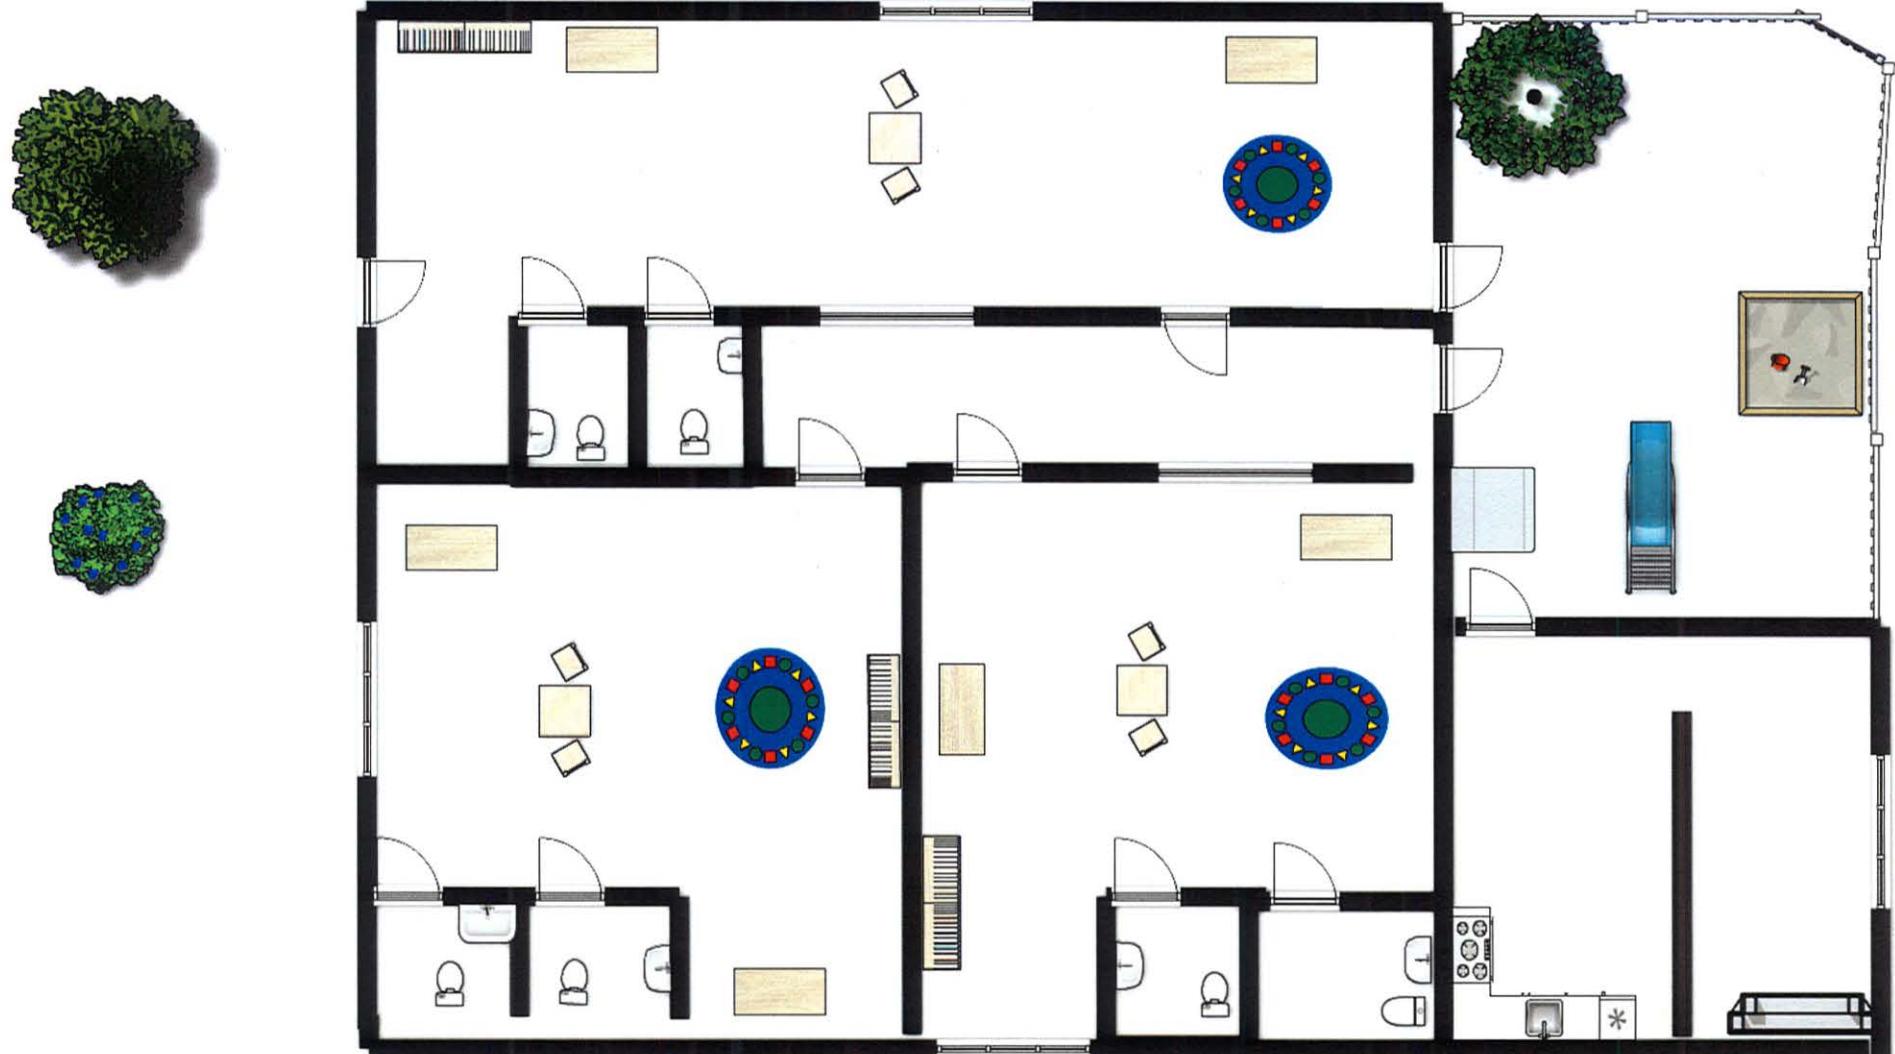
ix. Floor plan, Improvements Plans and Time table are attached.

Licencias requeridas	<ul style="list-style-type: none"> - Permiso de ARPE - Licencia Sanitaria - Certificación de Bomberos
Arreglos generales a la estructura	<ul style="list-style-type: none"> - Corregir filtraciones de techo - Corregir sistema eléctrico para que el mismo sea independiente. Conectar a sub estación localizada en los predios del coliseo. - La estructura debe contar con una acera de acceso que permita la entrada a persona con discapacidades - Se le debe colocar portones de acceso a la rampa de la facilidad para evitar el acceso a los niños
Cocina y Almacén de alimentos (Construir estructura en cemento con techo en garvalum)	<ul style="list-style-type: none"> - Cocina - Espacio 20 x 14 - Lámparas fluorescentes con protectores - Losetas en material poroso no resbaladizo - Fregadero de tres compartimiento - Estufa eléctrica de seis hornillas - Nevera industrial - Congelador industrial - Almacén espacio - 17' x 14' - Tablillero de metal (racks) - Ventanas con telas plásticas - Pared que divida los espacios - Techo con acústicos - Aire acondicionado

Descripción de cada salón	<ul style="list-style-type: none"> - Espacio de 700pc - Puerta de acceso (32 pulgadas) - Salida de emergencia (los salones pueden compartir esta salida de emergencia) - Losetas en material poroso no resbaladizo - Aire Acondicionado - Lámpara de emergencia - Detector de humo

<ul style="list-style-type: none"> - Ventanas (estilo Miami o cristal de seguridad) con telas plásticas - Lámparas fluorescentes con protectores - Dos baños
Baños	<ul style="list-style-type: none"> - Uno de los baños (6x6) de la facilidad debe cumplir con todos los requisitos de Ley ADA - Los restantes debe contar con un inodora de una altura máxima de - 14 pulgadas y un lavamanos a 22 pulgadas de altura del piso.
Área de patio exterior	<ul style="list-style-type: none"> - 1,500pc - Delimitar área frente a la cocina con verja de PVC de seis pies de alto (espacio entre cada columna de 3 pulgadas) - 1,000 pc en superficie engomada instalada en base de cemento, con sistema de drenaje y orillas resanadas a la altura del piso - 500pc en superficie de cemento plano (para área de locomoción)

- Hacer pruebas de carga eléctrica en las facilidades para determinar que la estructura eléctrica puede suplir lo necesario para los equipos a ser instalados
- Construir área para desperdicios (basura)
- Delimitar área de cisterna y compresores de a/c

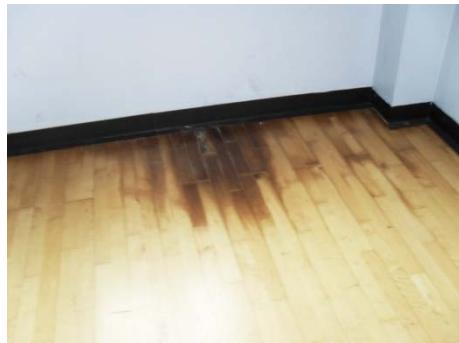
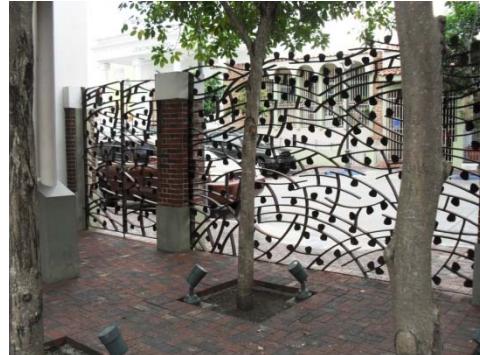
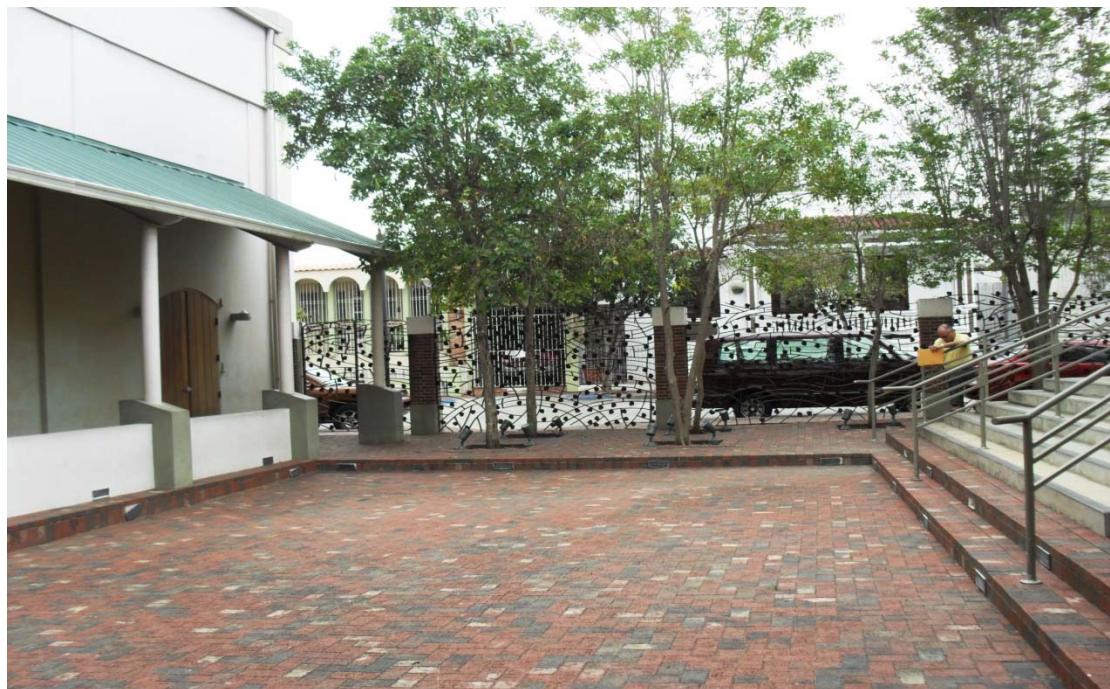
- a. The first location is the Interamerican University Technology Center
 - i. The location was visited and was considered as a temporary arrangement, as the Township has already other plans for this location.
 - ii. The gates are hazardous for children as they have rusty sharp ends.
 - iii. The location's floor is made out of wood and is infested with woodworms.
 - iv. Termites were observed on the walls.
 - v. The yard is a breeding ground for pigeons.
 - vi. Bathrooms are on the outside of the location.
 - vii. Fences are inadequate
 - viii. The space does not comply with the 35 sq. ft.-by-child performance standard.

- ix. Renovations would be too costly for use as a temporary location.
